Sanitary Survey Report

**Pisinemo Intertie
PWSID No. 0400030**

Survey Conducted on March 24, 2016

**Denver Fraser, P.E.
Sleeping Giant Environmental Consultants, LLP**

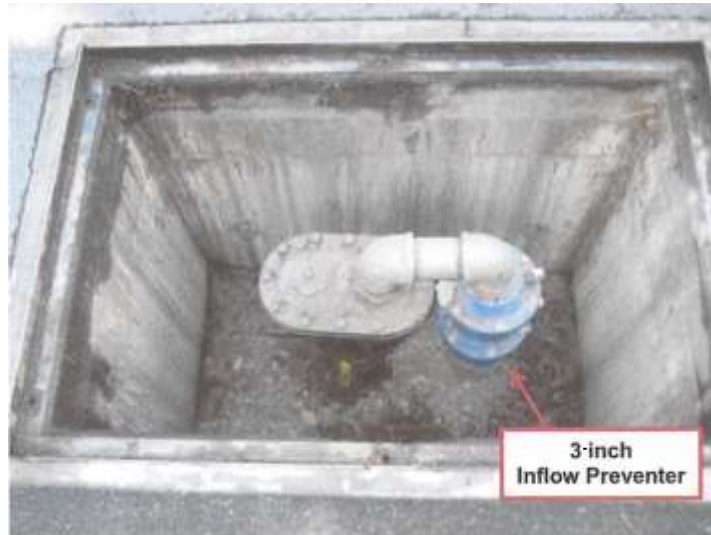
Recommendation: It is recommended that the TOUA air relief valves in the transmission lines and distribution system have proper backflow prevention. As stated above, design standards require the discharge piping for air relief valves be brought above grade; however, there are inflow preventers on the market that offer protection from contamination by flood water and vandalism (Photo below). Val-

matic makes the inflow preventer and these can be seen online. Additionally, it is recommended that more robust valve service vaults with locking lids be used to protect the air relief valves. These vaults could be made of cast iron and could be protected with bollards to prevent damage from vehicle traffic.

Val-Matic Floodsafe Inflow Preventer

- 2. Air Relief Valve Backflow Prevention and Vault Renovation – Health Risk Priority 2 (DS001 and DS002 – Code D3):** The transmission mains from the wells to the arsenic treatment plant have a number of automatic air release valves installed in shallow plastic vaults. These valve vaults are located near the road to the wells and have been subject to repeated damage from vehicle traffic and vandalism. Additionally, the air relief piping is below grade in the vaults, resulting in a potential backflow situation if the vaults flood. Modern design standards require the relief piping to extend a minimum of 12 inches above grade and terminate in a downward position with non-corrodible insect screen over the end of the pipe. It is understood that TOUA does not wish to extend the piping above grade due to previous vandalism where the relief pipe is used to break the valve off the transmission pipe, which results in a large leak (Photos 31-33).
